# Chapter 24

# The 1993 Warsaw Accident

### 24.1 The Background

On 14 September 1993, a Lufthansa Airbus A320 landed at Warsaw airport in a thunderstorm. Upon landing, none of the braking systems (air brakes, thrust reverse, wheel brakes) functioned for about nine seconds: the wheel brakes only started to function after about thirteen seconds. The aircraft ran off the end of the runway, collided with an earth bank and started to burn. Primarily because of the superb behavior of the crew, only two people died: one pilot, who died when the aircraft hit the bank, and one passenger, who was unconscious in the front corner and unnoticed in the evacuation as the cabin filled with smoke, and was asphyxiated. It became clear that the logic of the braking systems was indeed a reason why the braking systems hadn't functioned as expected. However, many commentators focused upon this factor as the main cause of the accident, which is probably incorrect. There were many other necessary causal factors (see Section 24.9). The final report itself ascribed pilot decisions and behavior as 'probable cause'. But what criteria are being used to determine this? The final report and commentary may be

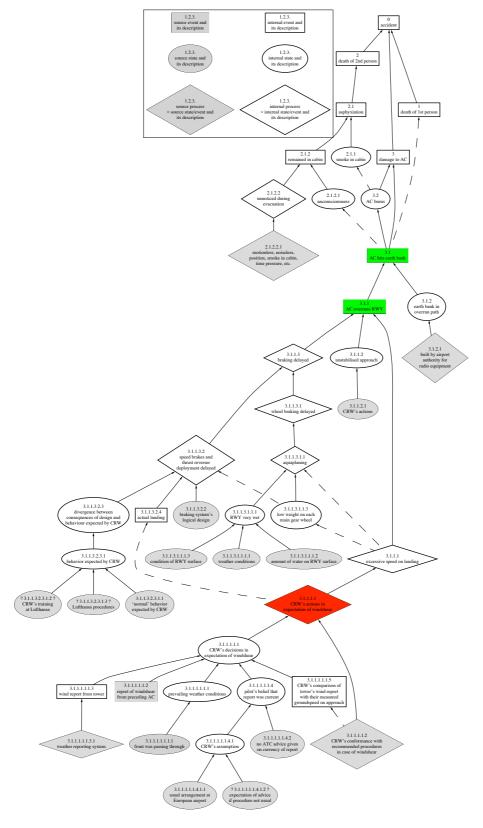
Figure 24.1: The Warsaw WB Graph

The overall structure of the WB-graph for this accident is given in Figure 24.1. We observe that this graph can be broken down into three main sections along the 'bottlenecks'. The 'top' section is shown in Figure 24.2 (The other two components are Figures 24.3 (the middle section) and 24.4 (the lower section).

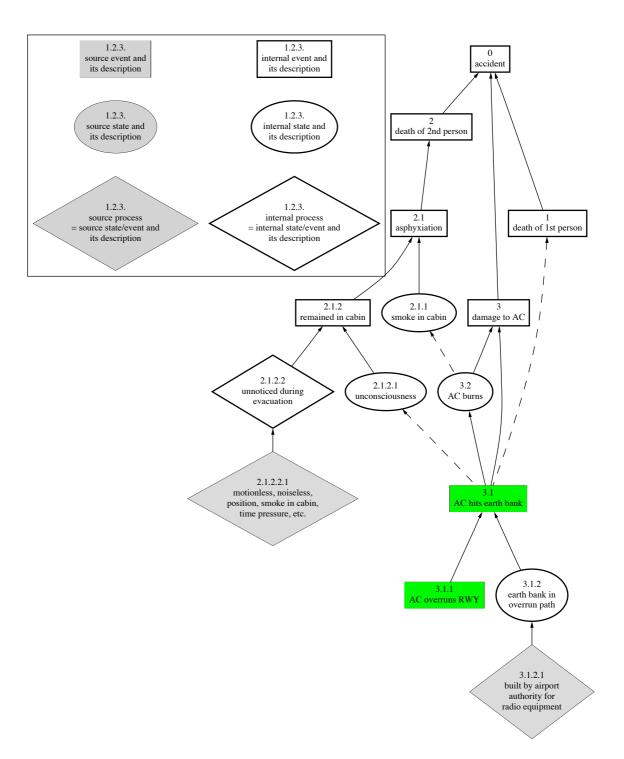
Figure 24.2: The Warsaw WB Graph – Upper Section

One can immediately observe from Figure 24.2 that node 3.1.2: earth bank in overrun path is a causally-necessary node: hitting the bank was a cause of the damage and fire; the hit directly killed one person and rendered the other unconscious and therefore unable to participate in the evacuation. The node is caused only by node 3.1.2.1: built by airport authority for radio equipment. This node in turn is not caused by any other event or state in the sequence. It is therefore to be counted amongst the 'original causes' of the accident, according to the WB-graph method. However, it does not appear amongst the 'probable causes' or 'contributing factors' of the final report. We have therefore found a reasoning mistake in the report. It is not the only such node of which this is true.
