A WBA of the Royal Majesty Accident

Peter Husemann, Peter B. Ladkin, Jan Sanders, Jörn Stuphorn
RVS Group, Faculty of Technology, University of Bielefeld

DRAFT VERSION of July 7, 2003

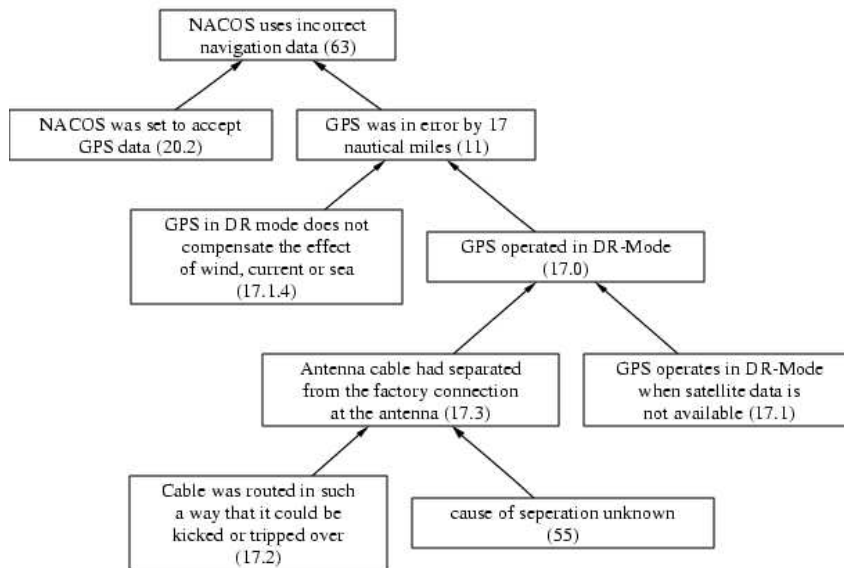
The WBG shown here is divided into a number of subgraphs using a “connector” notation which is not yet described in other documents on WBA. A *connector* is a node whose label consists entirely in the number from the List of Facts, surrounded by “*” symbols, as in the nodes labelled “* 54 *” and “* 63 *” in the main graph. These connector symbols indicate that the subgraph rooted at node 54 appears as a separate graph (in this case, the next graph). Using this method, we have split the WBG of the accident into 6 graphs.

The Why-Because Graph (WBG) is constructed by applying the Counterfactual Test to the List of Facts taken two at a time. The Counterfactual Test asks the question of Events, States or Processes A and B, which both happened, whether B would have happened had A not happened. If the answer is yes, the Test is passed and an edge drawn between the nodes in the WBG; if the answer is no, the Test is failed and no edge is drawn. The Counterfactual Test is underlain by a rigorous semantics. A formal logic exists for the semantics, and also for demonstrating whether a WBG is correct and complete according to certain precise criteria. Details may be found in the references [Lad01, LadLoe98]. We did not apply these additional formal criteria yet to check the graph we constructed.
