A WBA of the Royal Majesty Accident

Peter Husemann, Peter B. Ladkin, Jan Sanders, Jörn Stuphorn
RVS Group, Faculty of Technology, University of Bielefeld

DRAFT VERSION of July 7, 2003

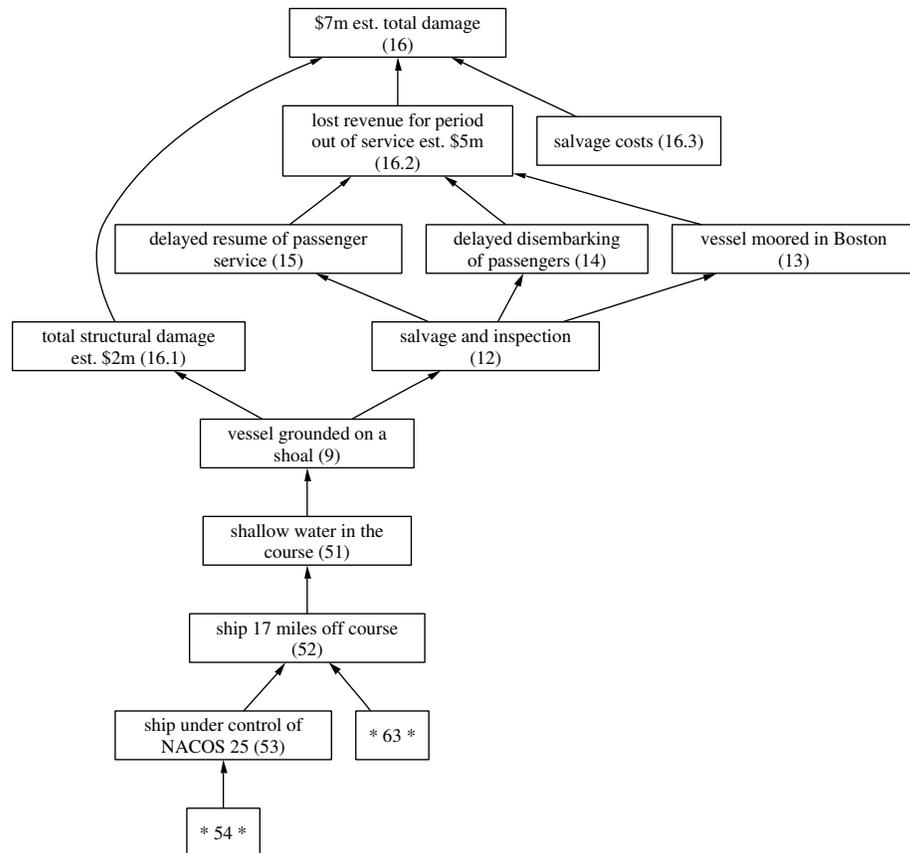
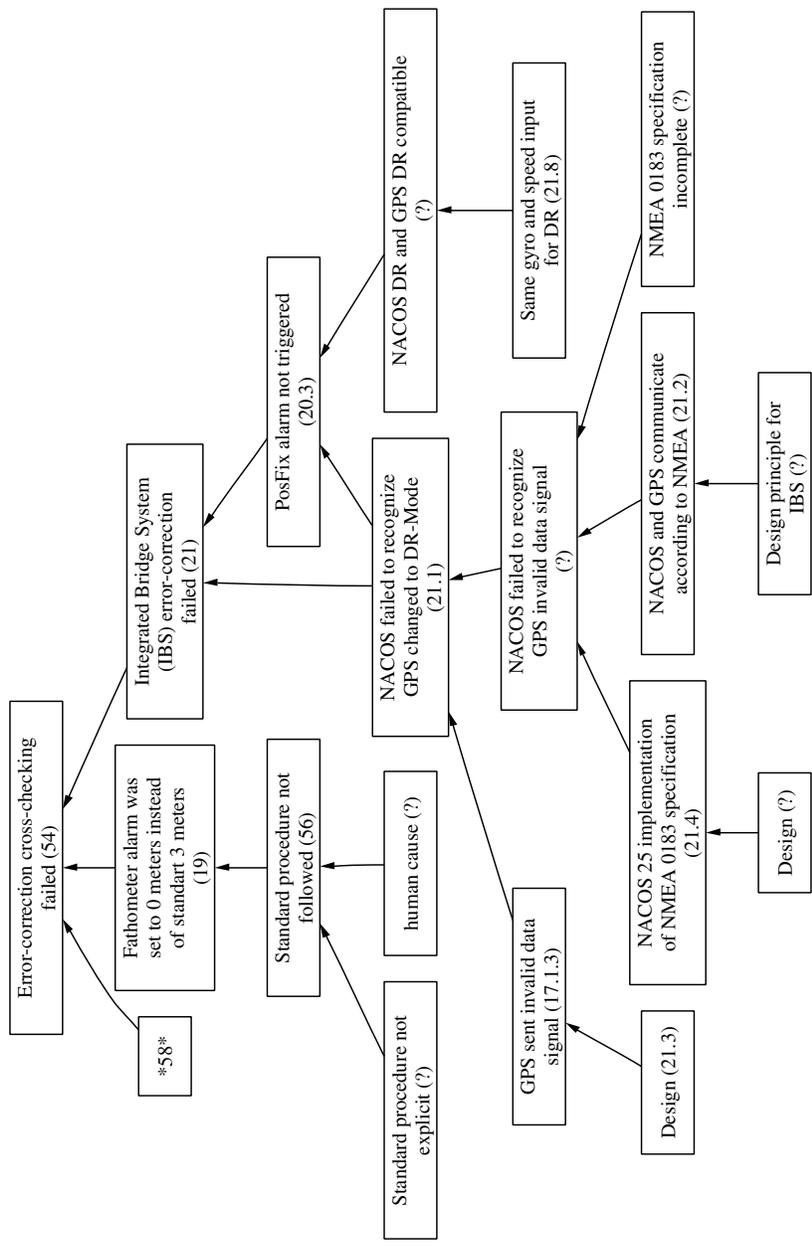
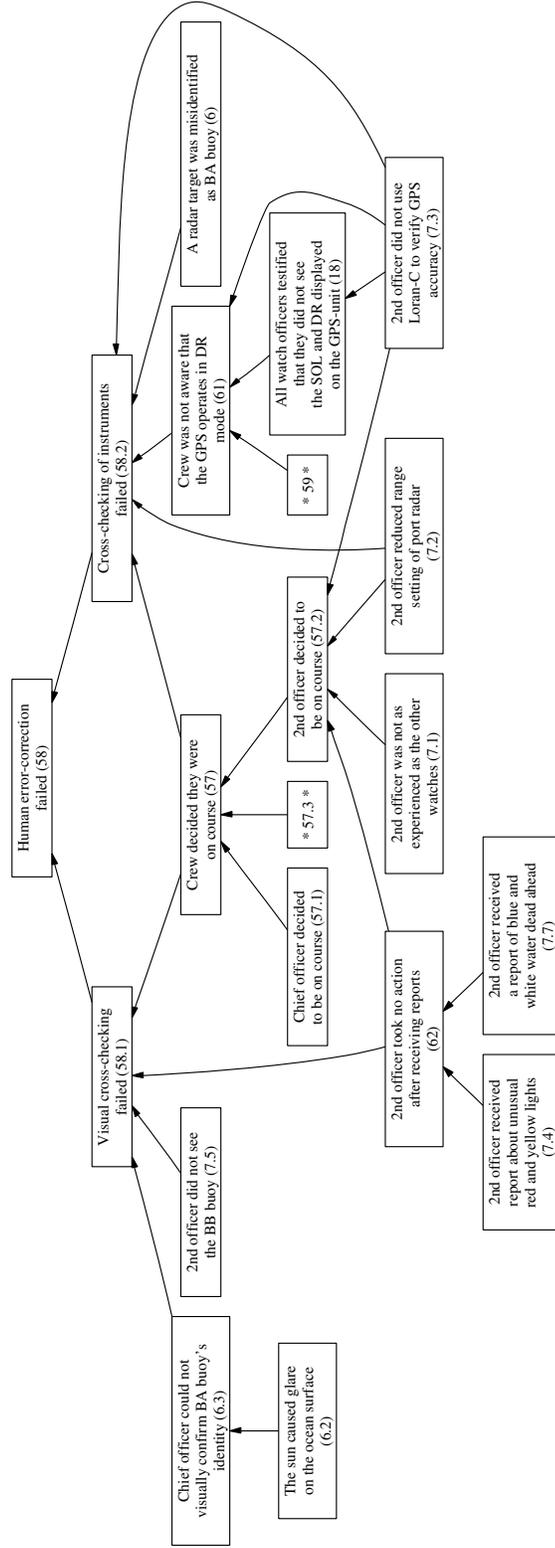
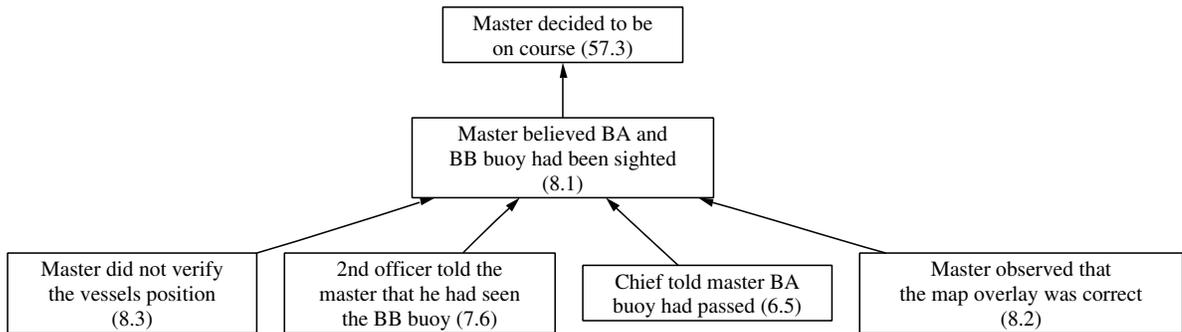
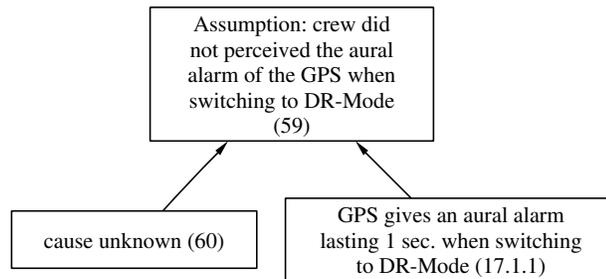
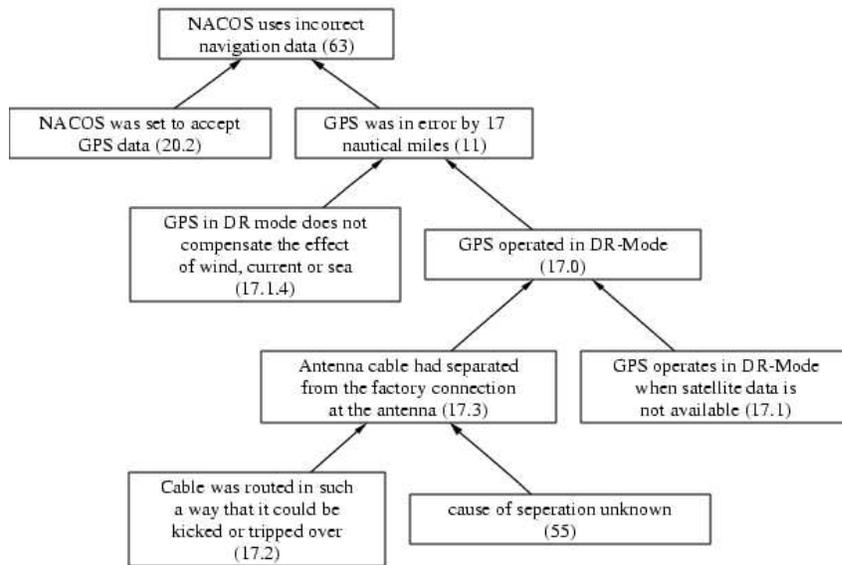
The WBG shown here is divided into a number of subgraphs using a “connector” notation which is not yet described in other documents on WBA. A *connector* is a node whose label consists entirely in the number from the List of Facts, surrounded by “*” symbols, as in the nodes labelled “* 54 *” and “* 63 *” in the main graph. These connector symbols indicate that the subgraph rooted at node 54 appears as a separate graph (in this case, the next graph). Using this method, we have split the WBG of the accident into 6 graphs.

The Why-Because Graph (WBG) is constructed by applying the Counterfactual Test to the List of Facts taken two at a time. The Counterfactual Test asks the question of Events, States or Processes A and B, which both happened, whether B would have happened had A not happened. If the answer is yes, the Test is passed and an edge drawn between the nodes in the WBG; if the answer is no, the Test is failed and no edge is drawn. The Counterfactual Test is underlain by a rigorous semantics. A formal logic exists for the semantics, and also for demonstrating whether a WBG is correct and complete according to certain precise criteria. Details may be found in the references [Lad01, LadLoe98]. We did not apply these additional formal criteria yet to check the graph we constructed.

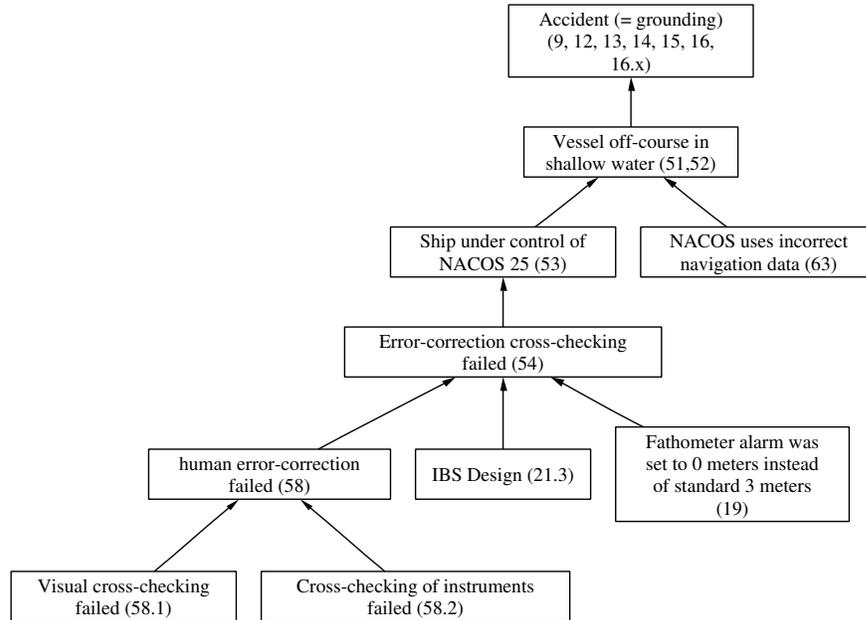
- 4.3 Epistemic construction, as in Conclusion 2 (*ConsEp*)
5. It is possible to obtain a reduction of the WBG which corresponds as far as possible to the NTSB statement of Probable Cause. This reduction is obtained by eliminating intermediate nodes and reducing paths passing through those intermediate nodes to direct edges between the remaining nodes to retain causal continuity. Lewis has suggested that causality is the transitive closure of the causal-factor relation; this operation corresponds to indicating causal factors or causality. Note that the nodes retained do not construe a *sufficient* set of causes, since that would require retaining a partition of the nodes below a given node. Neither Node LoF 63 *NACOS uses incorrect navigation data*, nor any partition below this node, is included in the causes of node LoF (9,12,...). Similarly, Nodes LoF 58 and LoF 19 are explicitly present, as is *part* of a partition below Node LoF 21 (provided that Node *IBS Design* is taken to include the three design-aspect nodes together, as well as the Node 21.8 *Same gyro and speed input for DR*. It may also be argued that Node LoF 63 could be included under *deficiencies in the design and implementation of the [IBS] and in the procedures for its operation*). However, that is not a partition of Node LoF 21, since nothing covers *NMEA 0183 specification incomplete*. It follows that a complete statement of causes has not been given in the NTSB statement of Probable Cause.

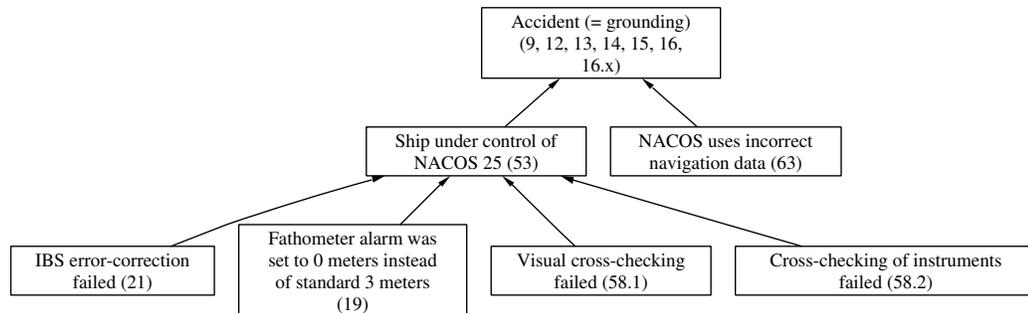
6. An abstraction of the WBG which includes a partition of the nodes, and which includes as far as possible the NTSB causes and contributing factors and minimal other material is given below. It requires some interpretation. Edges here represent *causes*, namely paths in the WBG between the indicated nodes. We regard Node LoF 53 *Ship under control of NACOS 25* as part of the “*overreliance*” causal assertion, and the Nodes LoF 63 *NACOS uses incorrect navigation data* and LoF 21 *IBS error-correction failed* as part of the “*deficiencies in ... [IBS]*” assertion, even though they occur in two different places in the causal display. Node LoF 58.2 *Cross-checking of instruments failed* we regard as part of the “*training in ... implications of this automation for bridge resource management*”, and Node LoF 58.1 *Visual cross-checking failed* we regard as encompassing “*second officer’s failure to take corrective action after ... cues*”. Although this interpretation is liberal, it does provide a partition of the WBG. However, it includes Node LoF 19 *Fathometer alarm was set to 0 meters instead of standard 3 meters*, which cannot be subsumed, even liberally, under any of the categories of the NTSB’s statement of Probable Cause. We conclude that the NTSB statement of Probable Cause is incomplete, even under a liberal interpretation.

7. It is unclear to us, though, whether the fathometer and its alarm is regarded as part of the IBS. It is a separate entity from the other components, hardly “integrated” with them. The NTSB report describes the IBS on pp13-19, and deals exclusively with the STN Atlas NACOS 25, the Raytheon RAYSTAR 920 GPS unit, and the Raytheon RAYNAV 780 Loran-C unit. If the fathometer is indeed regarded as part of the IBS, then its inadequate setting could be regarded with some stretch of the imagination under “overreliance...” as well as “[inadequate training] in... the implications of the automation for bridge resource management”. Our inclination is not to take it as part of the IBS, since it is not apparently integrated with the other components, and indeed not setting the alarm to 3 meters when under way appears to us to be a failure to follow basic procedures, only peripherally connected with the focus on the IBS explicated in the statement of Probable Cause.

8. The WBG abstraction, then, while technically an explanation of cause (since it includes a partition of the WBG) contains a cause not contained in the NTSB statement of Probable Cause. That statement also includes further items not mentioned in the body of the report, but in the conclusions, namely the training program of Majesty Cruise Lines, and the lack of adequate performance standards for IBSs. However, the inadequacy of international watchkeeping standards for IBS-equipped vessels appears in the statement of Probable Cause for the first time.

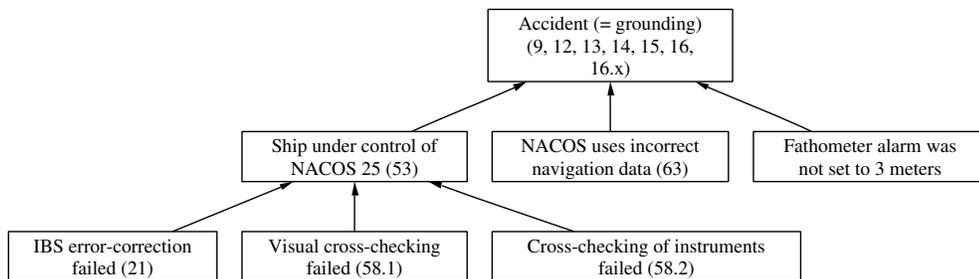
9. The Node LoF 19 *Fathometer alarm .. set to 0 meters instead of .. 3 meters* appears where situated above because of a classification we introduced into the WBA, a *Con-struct*. NTSB Conclusion 5 states counterfactually that the grounding would have

been avoided had the alarm been set to standard 3m. If so, this would suggest that the negative formulation *Fathometer alarm not set to 3m* is a causal factor of the grounding, by the WBA principle that an absent factor (something was *not* the case) is reifiable if it states a violation of procedure, and by the Counterfactual Test applies to this reified absent factor. The resultant WBG with this negative factor is shown below. This brings out the curious feature that a negative factor (created by the absence of procedure-following) and its positive formulation (what in fact happened, instead of what the procedure dictates) may have causal influence in quite different places. Although it is not guaranteed that the Counterfactual Test applied to causes (a node at the end of a chain of causal-factor relations) will succeed (the notion of causal factor is notoriously not transitive), it may well be that it might in certain cases. This suggests that a statement of causality as in the WBG-abstraction above may be suitably reformulated by considering whether subsidiary nodes are indeed direct causal factors of the accident. This suggests that essentially the same analysis may be presented in more than one way.

- The question remains whether the partition above represents the neatest statement of probable cause of the accident. Intuitively, it seems to us that the reason the ship ran aground was that it was under control of the NACOS 25 (LoF 53), which was using incorrect navigation data (LoF 63) because the GPS antenna cable separated and neither standards nor design enforced uniform IBS notification methods for incorrect data. In addition to this, there was a massive failure of traditional seamanship (watchkeeping, setting the fathometer alarm), as well as of cross-checking the IBS equipment. The abstraction above does not mention the GPS cable separation, but (again under the negative formulation) the Counterfactual Test shows its importance: *had the cable not*

separated, the IBS would have obtained correct nav data and been on course and would not have run aground. The separation of the cable was a necessary causal factor in the grounding.
